Village of Lindenhurst Construction Update – August 12, 2016

Beck Road Reconstruction

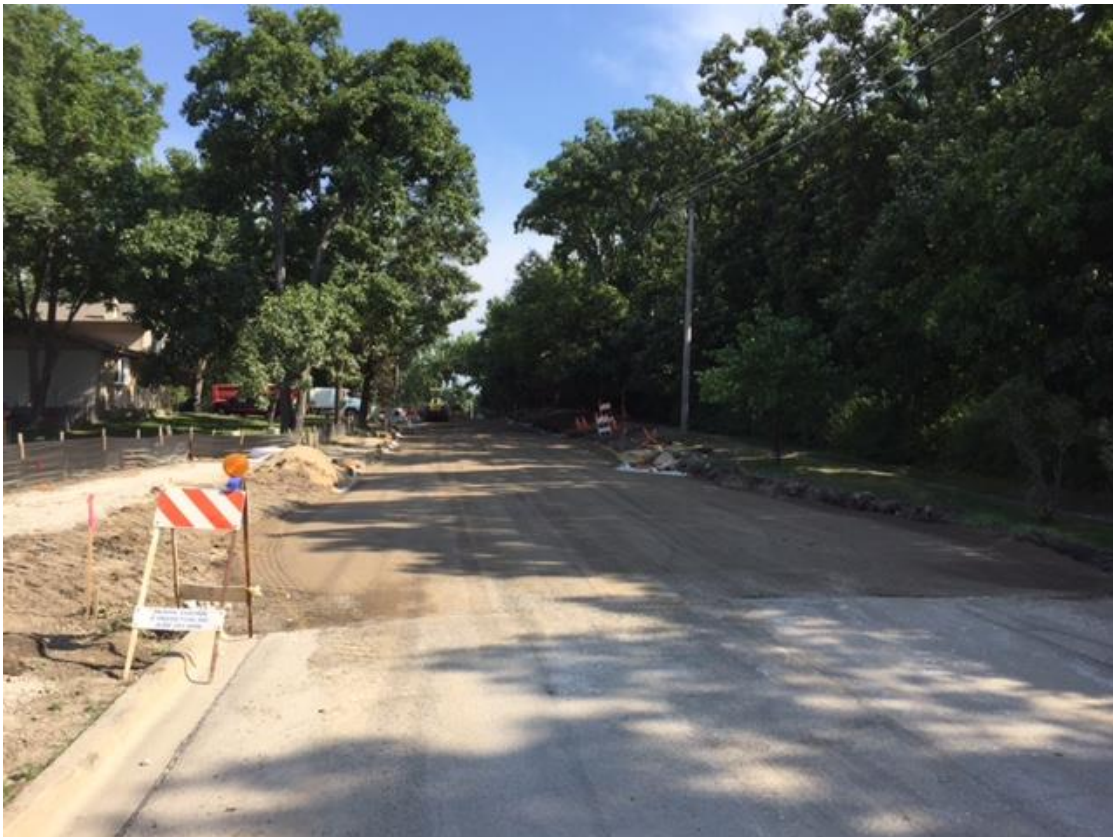
Beck Rd. looking north from Kelsey Road - base course placement

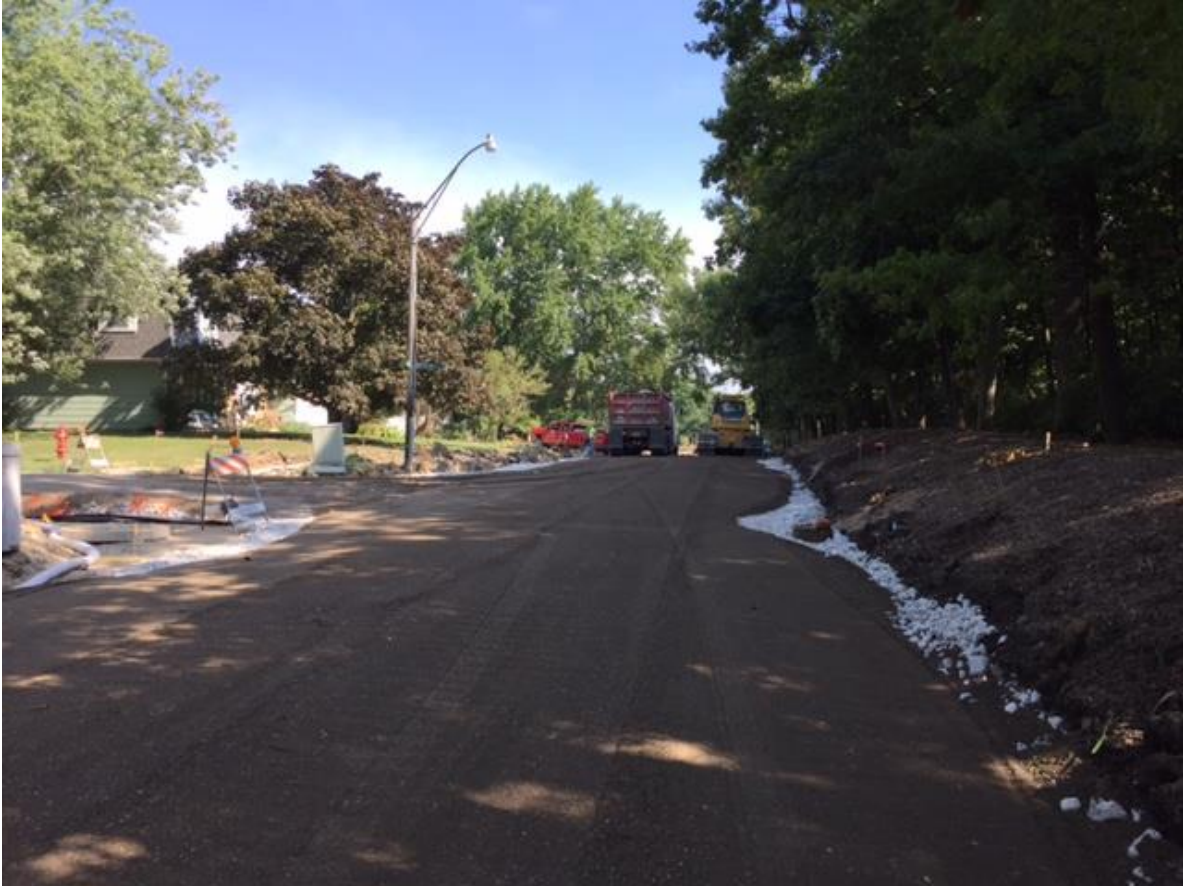
Beck Rd at Springhill- base placement

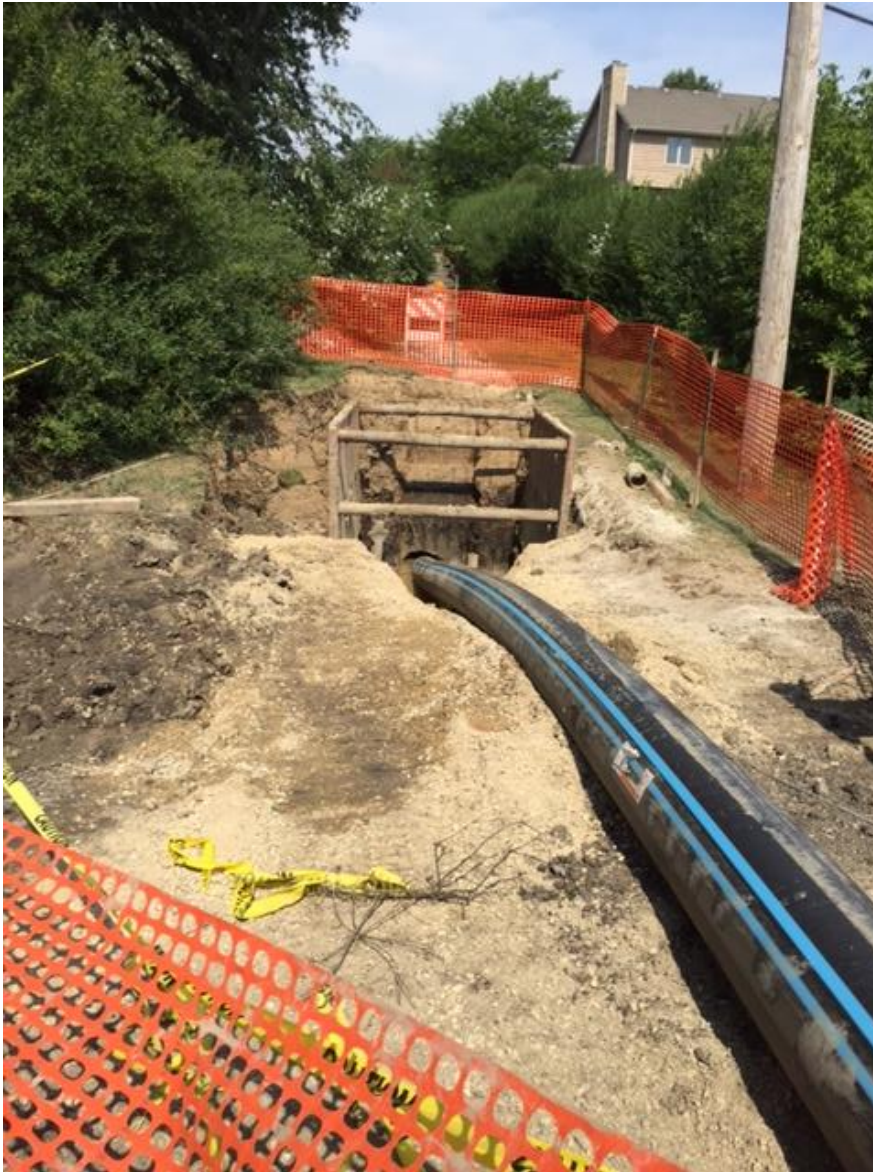
The connection from Hickory Court to Robincrest Lane has begun during this week, the pipe is being directionally drilled and then pulled through the bore hole, this main has been installed and needs to be connected to the system.

Hickory Ct, Directional drilling operation

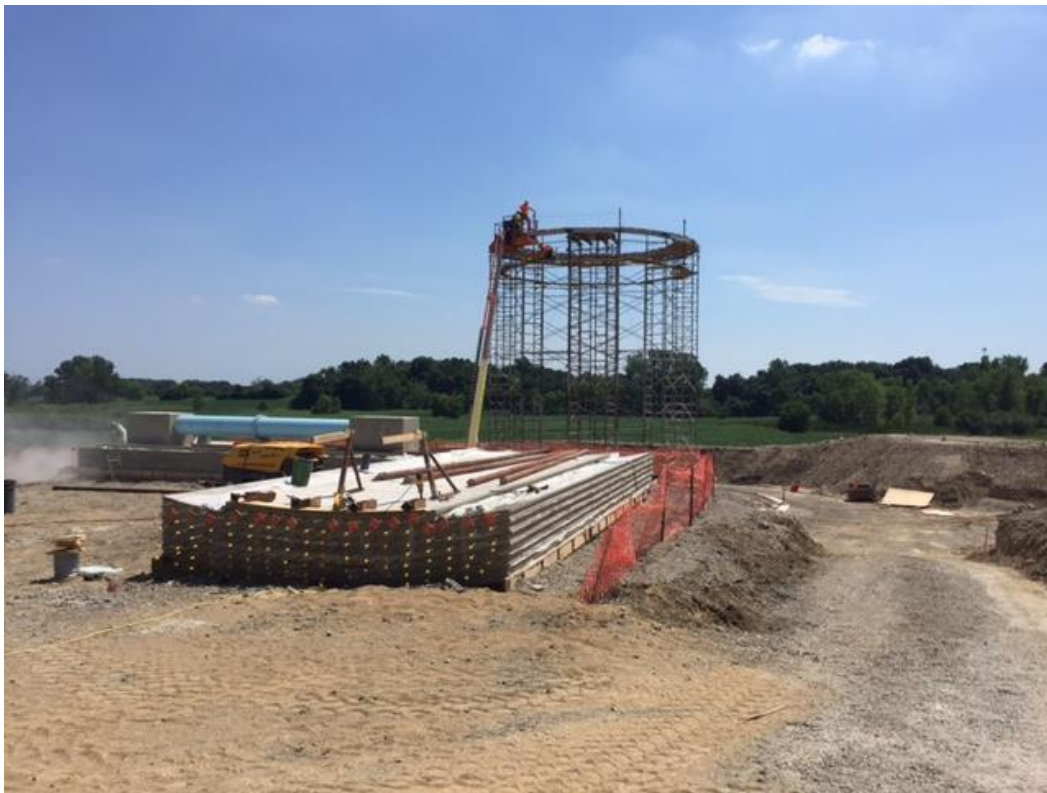
Great progress has been made on this project this week, the pre-cast wall sections and the roof sections have been installed. They will be working on the grouting of the gaps between the sections in the next few weeks. See the next 2 photos for progress.

Pre-Cast sections (foreground) and scaffolding for reservoir in background.
